USAAEFA PROJECT NO. 80-07

CLIMATIC LABORATORY SURVEY HUGHES YAH-64 HELICOPTER

FINAL REPORT

MARCH 1982

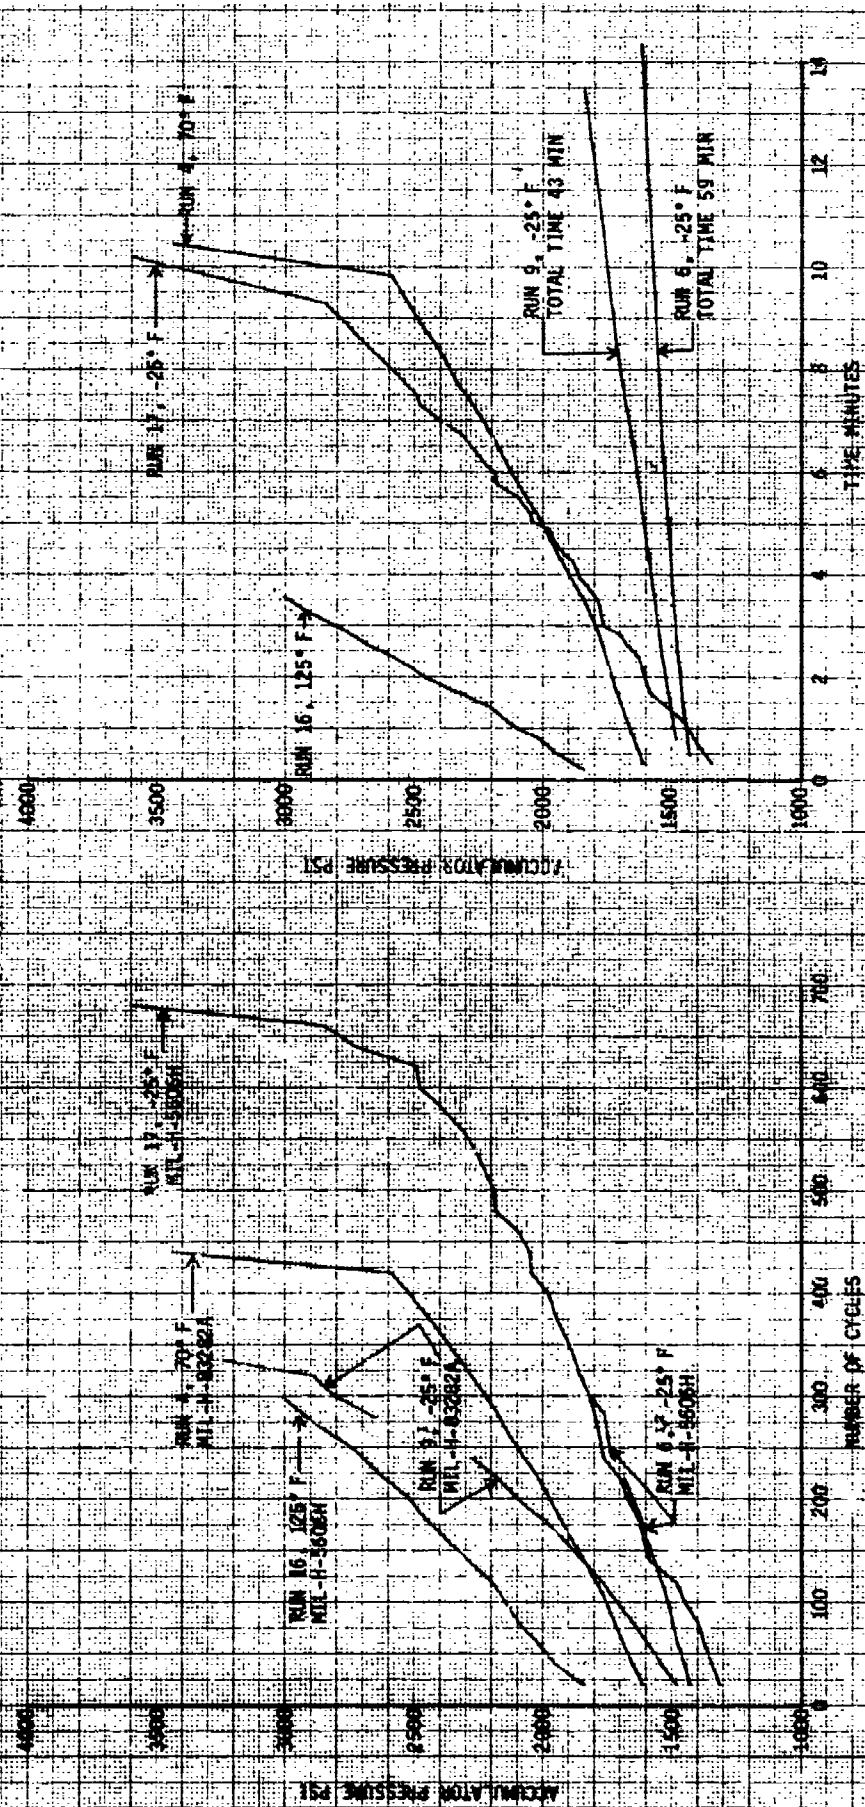
FIGURE 1
UTILITY MANIFOLD TO ACCUMULATOR AND HAND PUMP EFFICIENCY
YAN-45 USA S/N 7A-22249

37. The utility hydraulic hand pump was evaluated for efficiency and ease of operation. Fluid was supplied to the pump under pressure from the utility manifold reservoir. Each test was started by depleting the accumulator hydraulic pressure, reading and servicing the nitrogen precharge if necessary, and pressurizing the accumulator with the hand pump. The pump, when serviced with either fluid, operated satisfactorily at 70° and 125°F requiring from 3.5 to 10 minutes and 300 to 460 strokes to pressurize the system to 3000 pounds per square inch (psi). Resistance was encountered throughout the full travel of the stroke and increased the pressure in the accumulator from 3.5 to 4.1 psi per stroke. The pump was less effective at -25°F tests with MIL-H-83282A fluid. It was necessary to allow from 10 to 15 seconds between strokes to fill the pump cylinder to produce a full stroke. Midway through the charging cycle the pump cylinder would not fill and pressure dropped from 4.5 to less than 1 psi increase per stroke. Pressurized air was applied to the utility manifold reservoir through the pressurized air system (PAS) air inlet check valve. The pump then functioned properly to complete the charge cycle. On another occasion, this procedure was used but the pump would not begin to work. Figure 1 shows the number of strokes required to charge the accumulator. A new utility manifold was installed and a second test conducted at -25°F using MIL-H-5606H fluid. The pump charged the accumulator to 3000 psi in 10 minutes averaging 2.4 psi per stroke. There was a reduced efficiency of 32% (an increase of 220 strokes to achieve the same pressure in the same time) compared to the 70°F tests. The pump operation at -50°F with MIL-H-5606H fluid was unsatisfactory. An increase to 30 to 40 seconds between strokes was required to allow the pump cylinder to fill with fluid and less than 50% of the pump handle travel produced any pressure increase.

EXTERNAL AIR APPLIED TO UTILITY MANIFOLD RESERVOIR TO PRESSURIZE HYDRAULIC RETURN SYSTEM
PRESSURIZATION OF UTILITY ACCUMULATOR WITH HAND PUMP ADJUSTED ENGINE START ACCOMPLISHED WITH EXTERNAL PNEUMATIC STARTING UNIT.

Further evaluations of the pump at this temperature were terminated and the accumulator charged using an external hydraulic power cart. The inadequate hand pump operations at -25°F with MIL-H-83282A and at -50°F with MIL-H5606H is a deficiency.

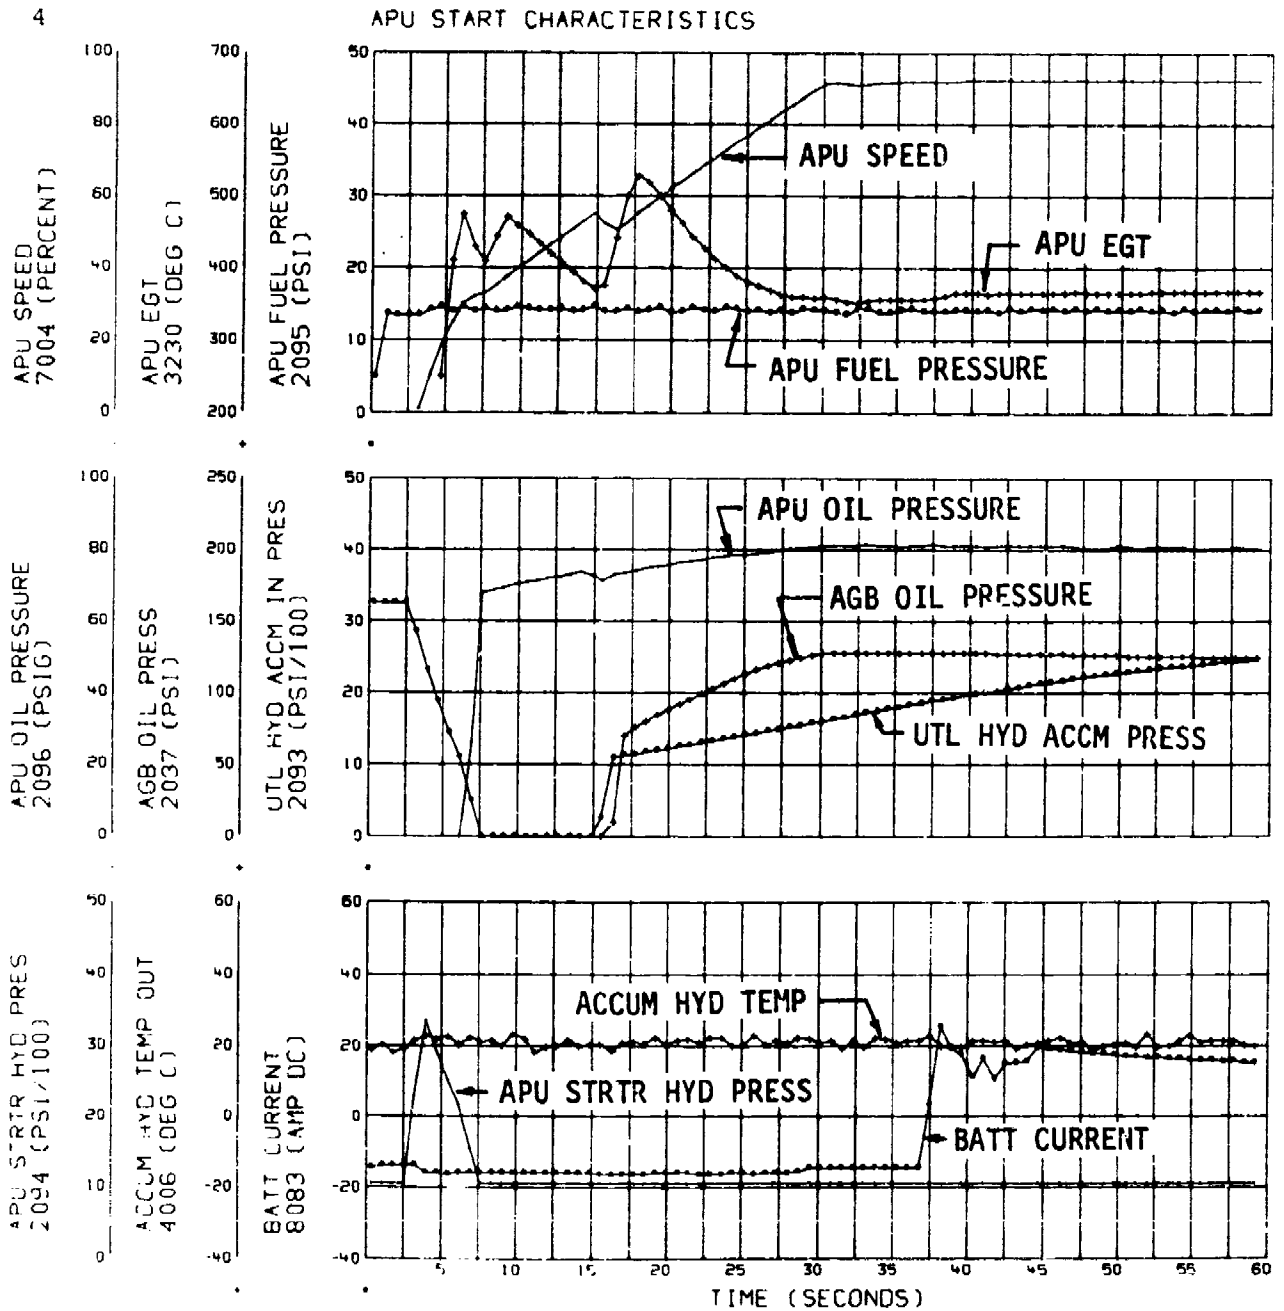
FIGURE 2
APU START CHARACTERISTICS
APU S/N P113
YAH-64 USA S/N 74-22249
CLIMATIC LABORATORY TEMPERATURE -25°F

7. The auxiliary power unit (APU) was started by a hydraulic starter motor which was driven by the utility hydraulic accumulator. The APU was started at all temperatures prior to main engine starts, (accessory gear box (AGB) not turning), and at the end of test runs, prior to shutting down the main engines (AGB turning) (figures 1 through 12, app E). The APU never failed to start when the accumulator nitrogen precharge and total pressure were correct. At the first 70°F and -25°F test conditions and at 125°F and 0°F the APU started and attained full operating speed on every attempt with the AGB not turning (figs 1, 2, 7, and 8, app E). Every start attempt was successful at all temperatures with the AGB already turning.

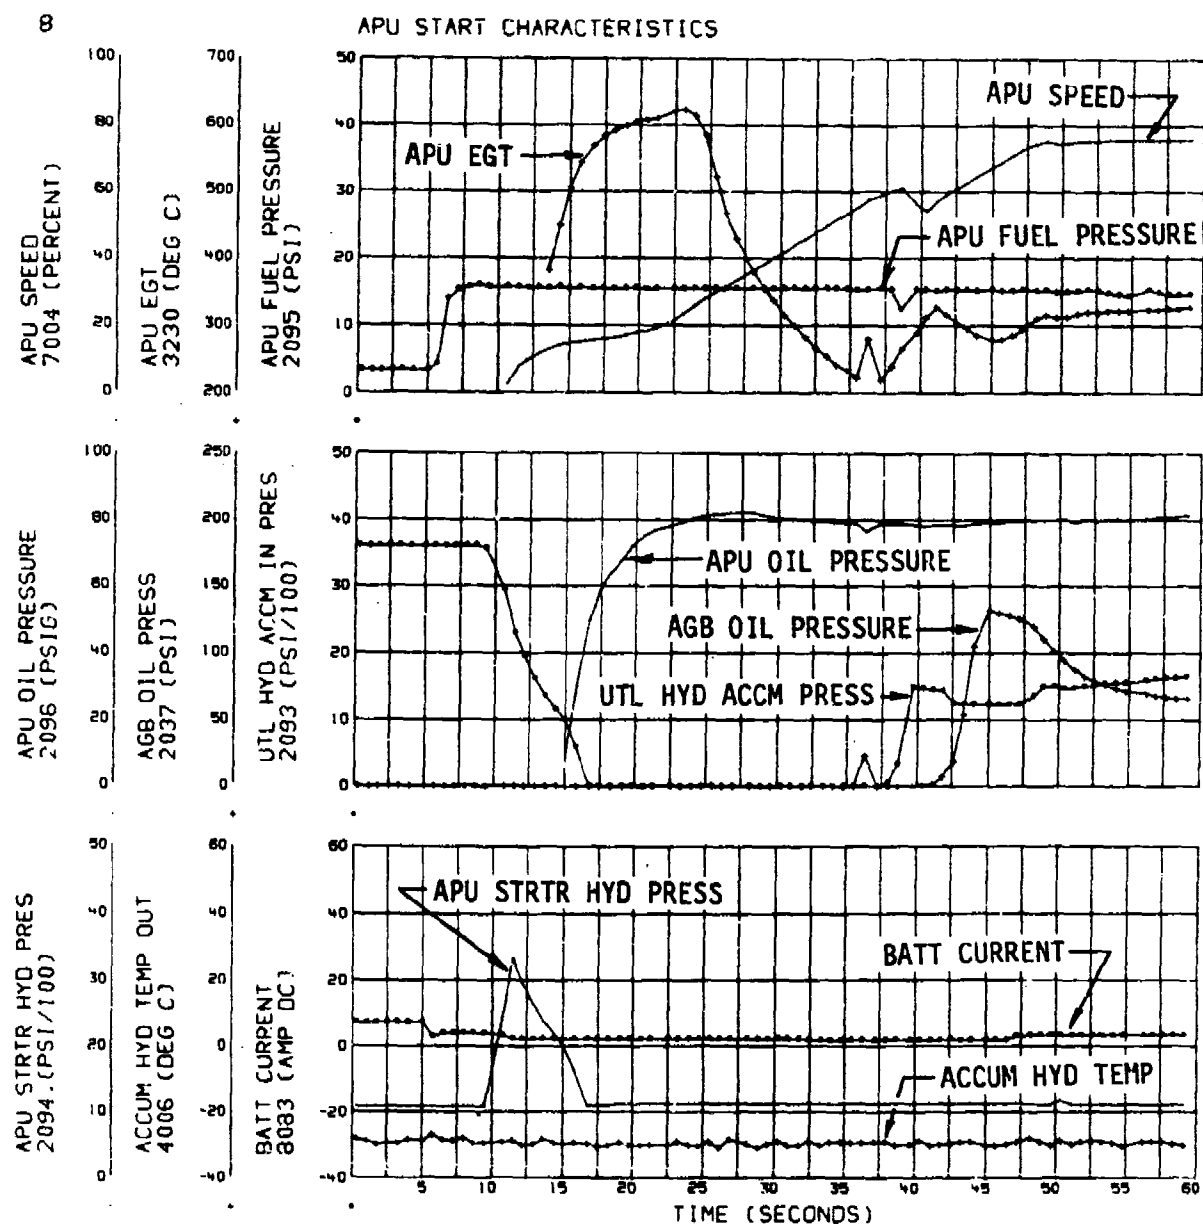
FIGURE 3
APU START CHARACTERISTICS
 APU S/N P113
 YAH-64 USA S/N 74-22249
 CLIMATIC LABORATORY TEMPERATURE -25°F

9. A second -25°F test condition was added to the planned tests primarily to evaluate APU starts with the new clutch installed. Start attempts with the AGB not turning resulted in the APU

starting and accelerating to clutch engagement then decelerating to zero (fig 3, app E). Prior to this second -25°F test, the lubricating oil and hydraulic fluid had been changed to MIL-L-7808H and MIL-H-5606H, respectively.

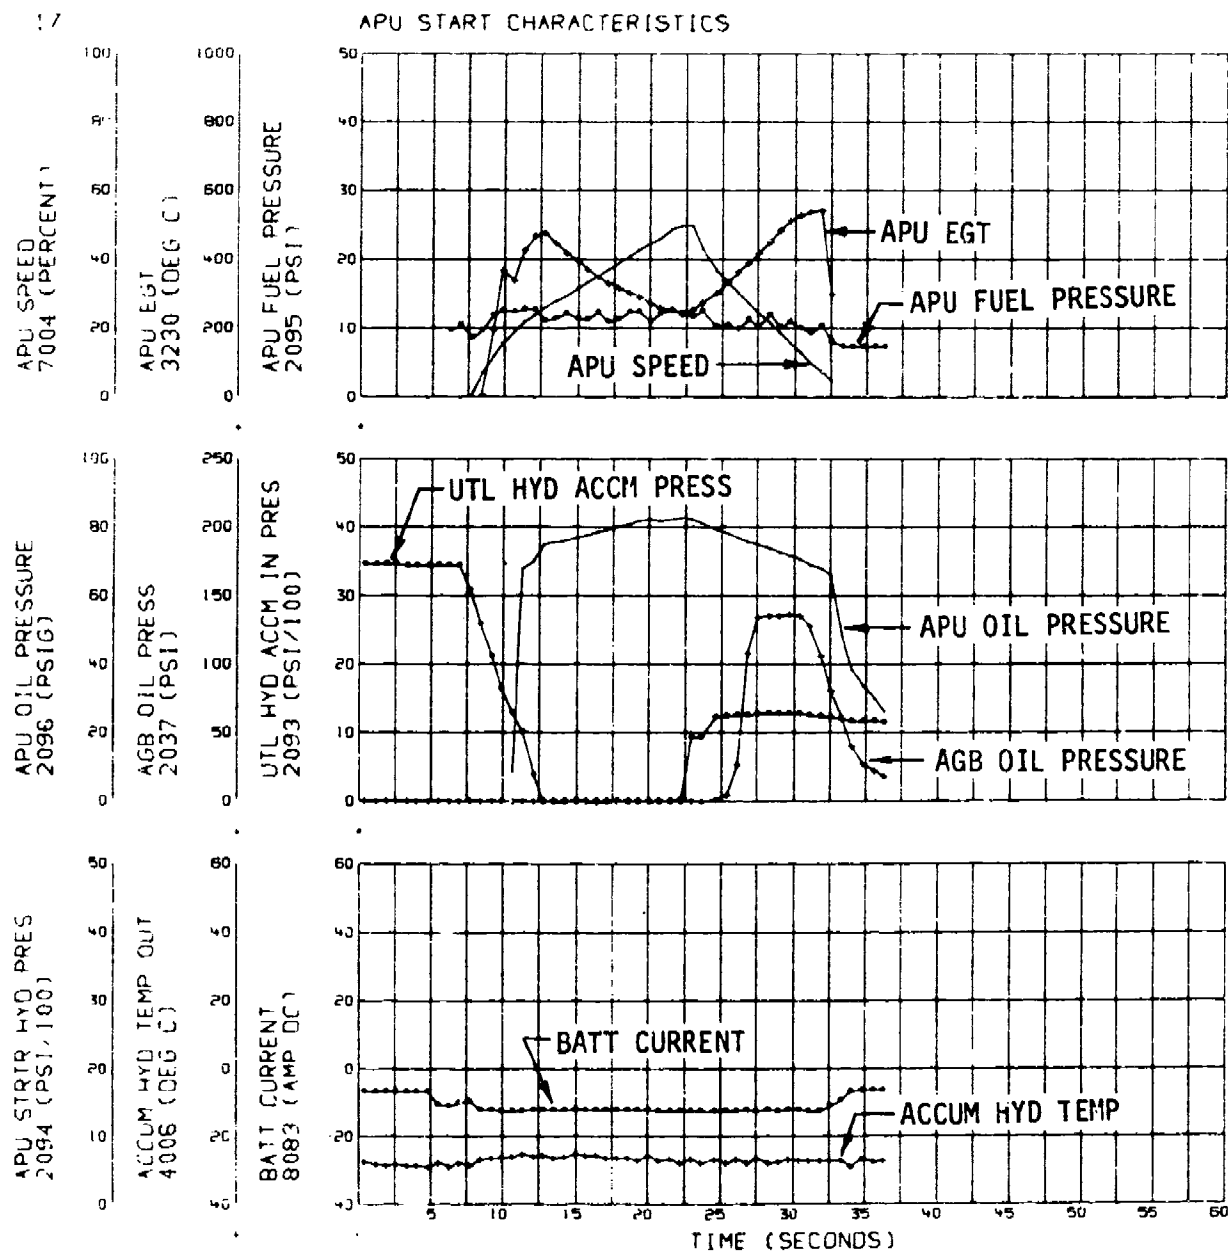
FIGURE 4
APU START CHARACTERISTICS
 APU S/N P113
 YAH-64 USA S/N 74-22249
 CLIMATIC LABORATORY TEMPERATURE -25°F

10. A manual switch was then installed at -25°F to allow engagement of the clutch at 90 percent speed rather than 60. One start attempt was made and the APU and AGB achieved operating speed (fig 4, app E). This switch was a test item and not part of the standard YAH-64 configuration.

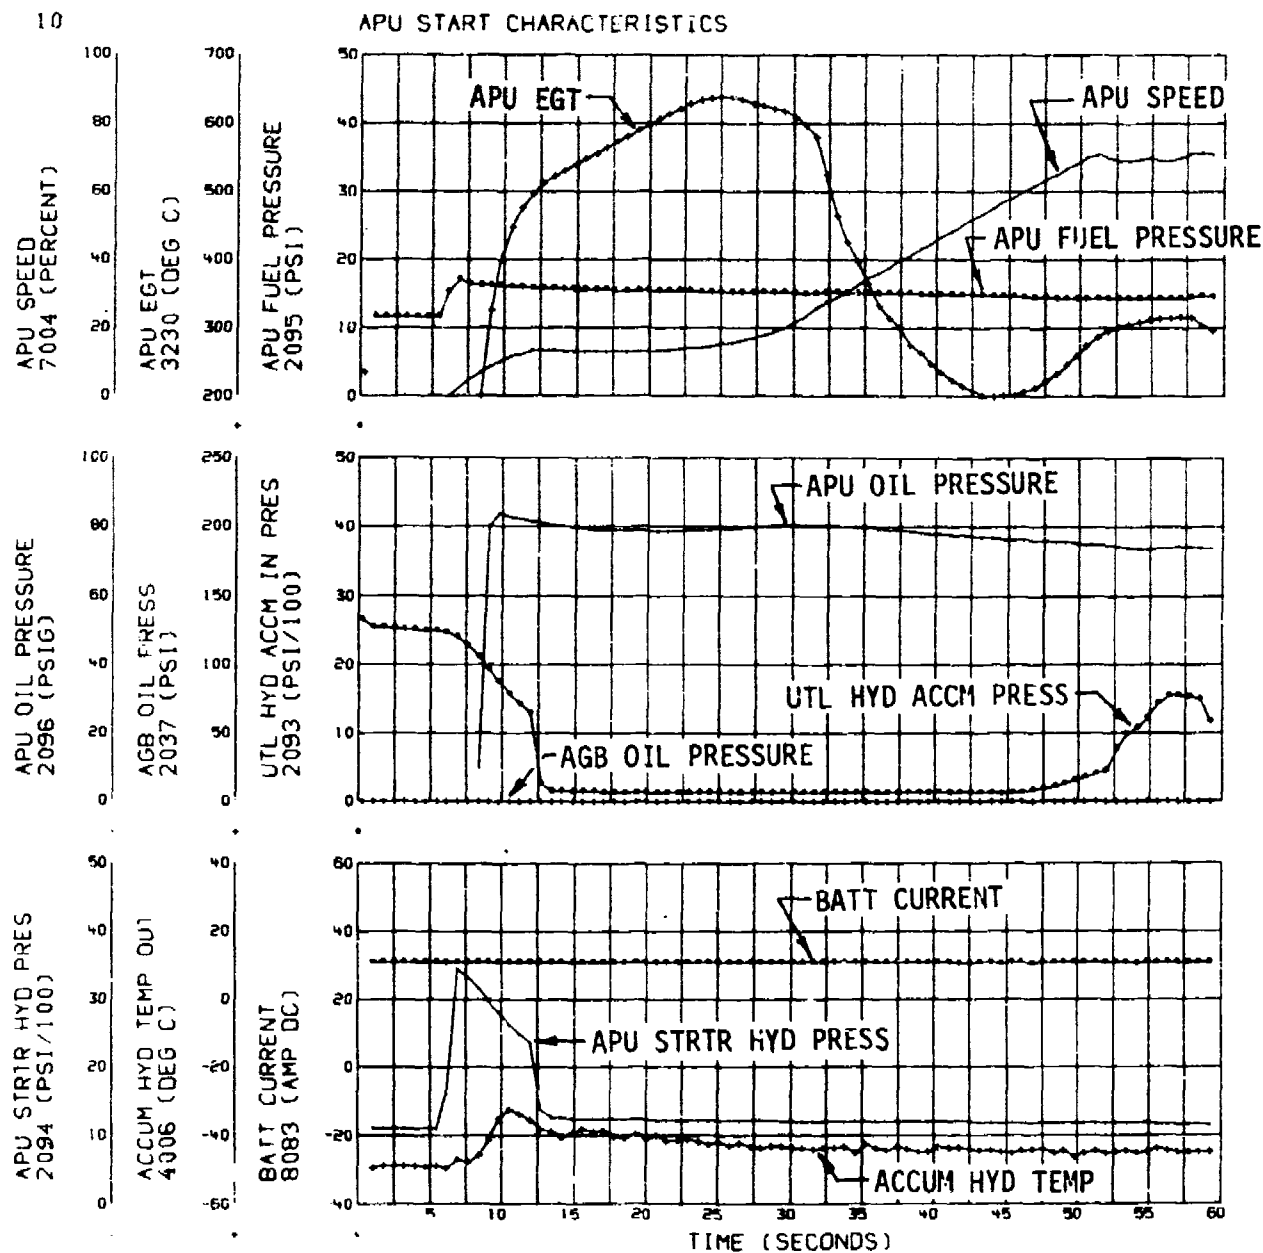
FIGURE 6
APU START CHARACTERISTICS
 APU S/N P113
 YAH-64 USA S/N 74-22249
 CLIMATIC LABORATORY TEMPERATURE -50°F

8. On the first start attempt at -50°F the APU-to-AGB clutch failed (fig 5, app E). The APU achieved operating speed, but could not turn the accessory gearbox. A new clutch was installed and several more start attempts were made. The APU started on each attempt and accelerated to clutch engagement (approximately 60 percent speed). When the clutch engaged, the APU speed decreased to zero and the start sequence was aborted by the APU control unit (fig 6, App E). No problems were encountered at the subsequent 70°F nor $+125^{\circ}\text{F}$ test conditions.

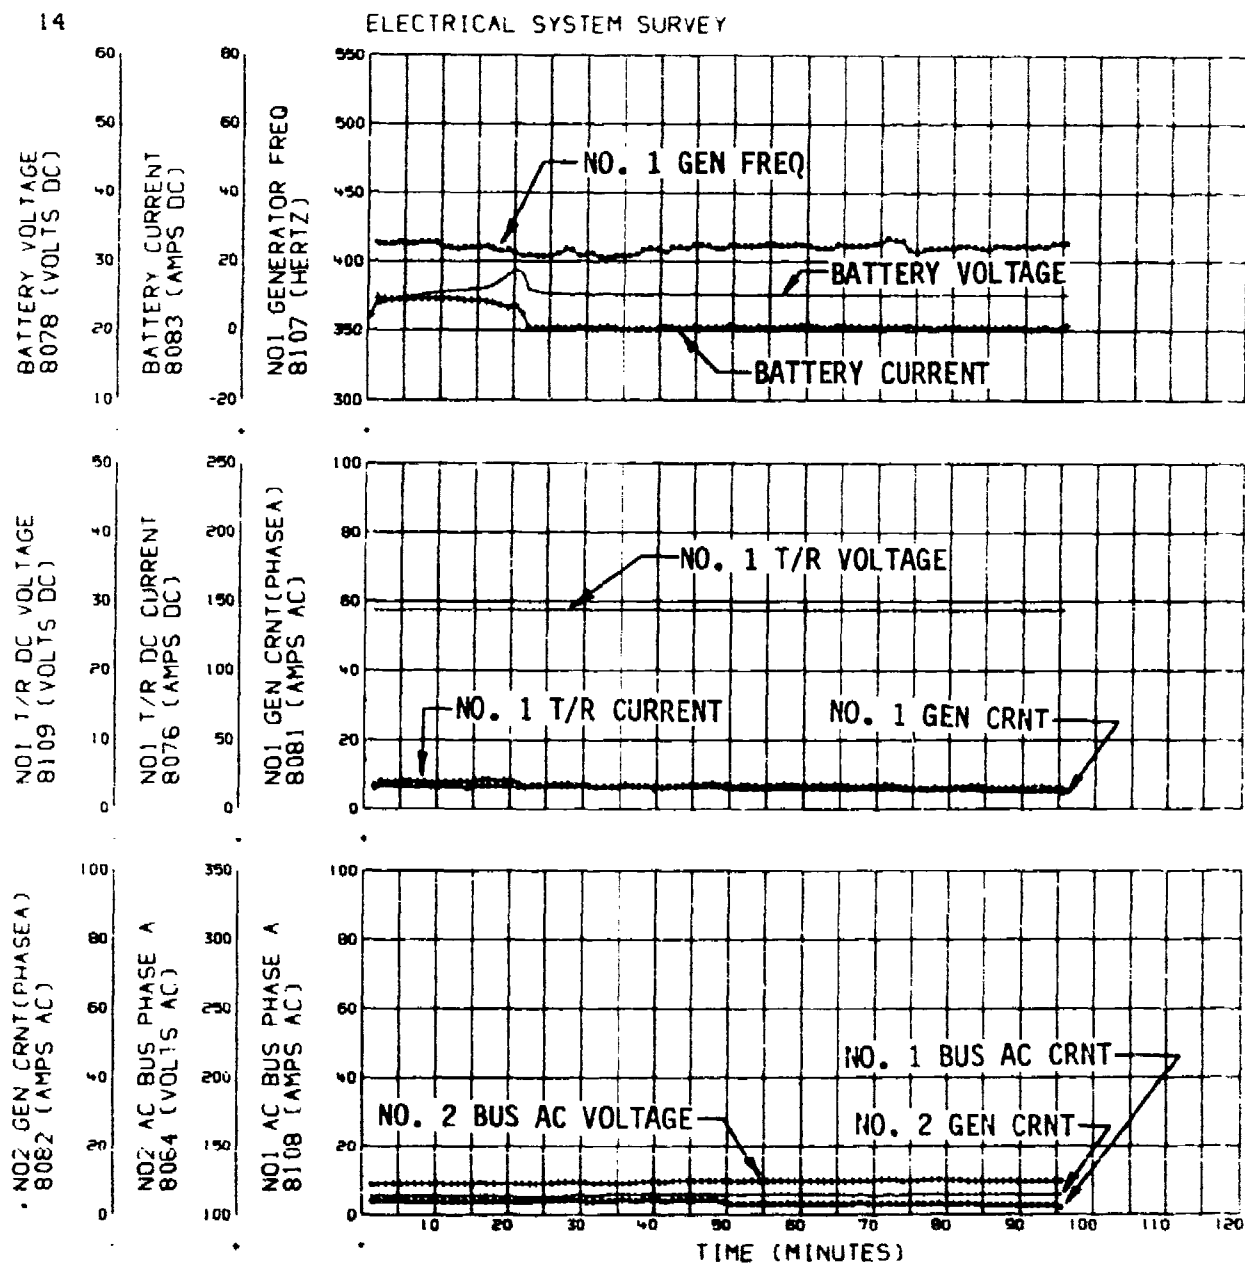
FIGURE 49
ELECTRICAL SYSTEM SURVEY
 YAH-64 USA S/N 74-22249
 CLIMATIC LABORATORY TEMPERATURE 125°F

temperature and the voltage dropped to 24 volts, battery potential for the rest of the test (fig. 49, app E). The failure of the DC charging system at 125°F is a shortcoming.

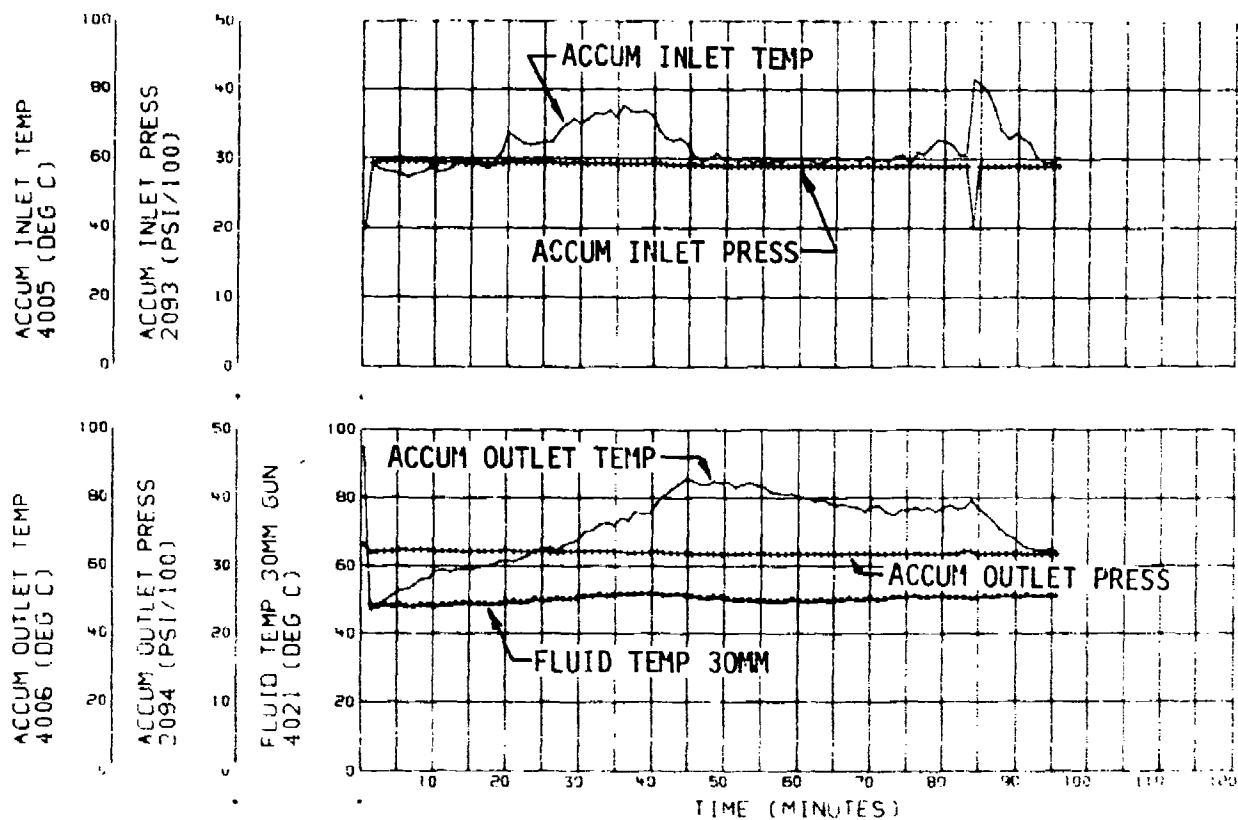
FIGURE 61
UTILITY HYDRAULIC SYSTEM SURVEY - B
YAH-64 USA S/N 74-22249
CLIMATIC LABORATORY TEMPERATURE 125°F

- NOTE:
1. HYDRAULIC SYSTEM SERVICED WITH MIL-H-5606H FLUID
 2. ACCUMULATOR OUTLET PRESSURE INSTRUMENTATION UNRELIABLE

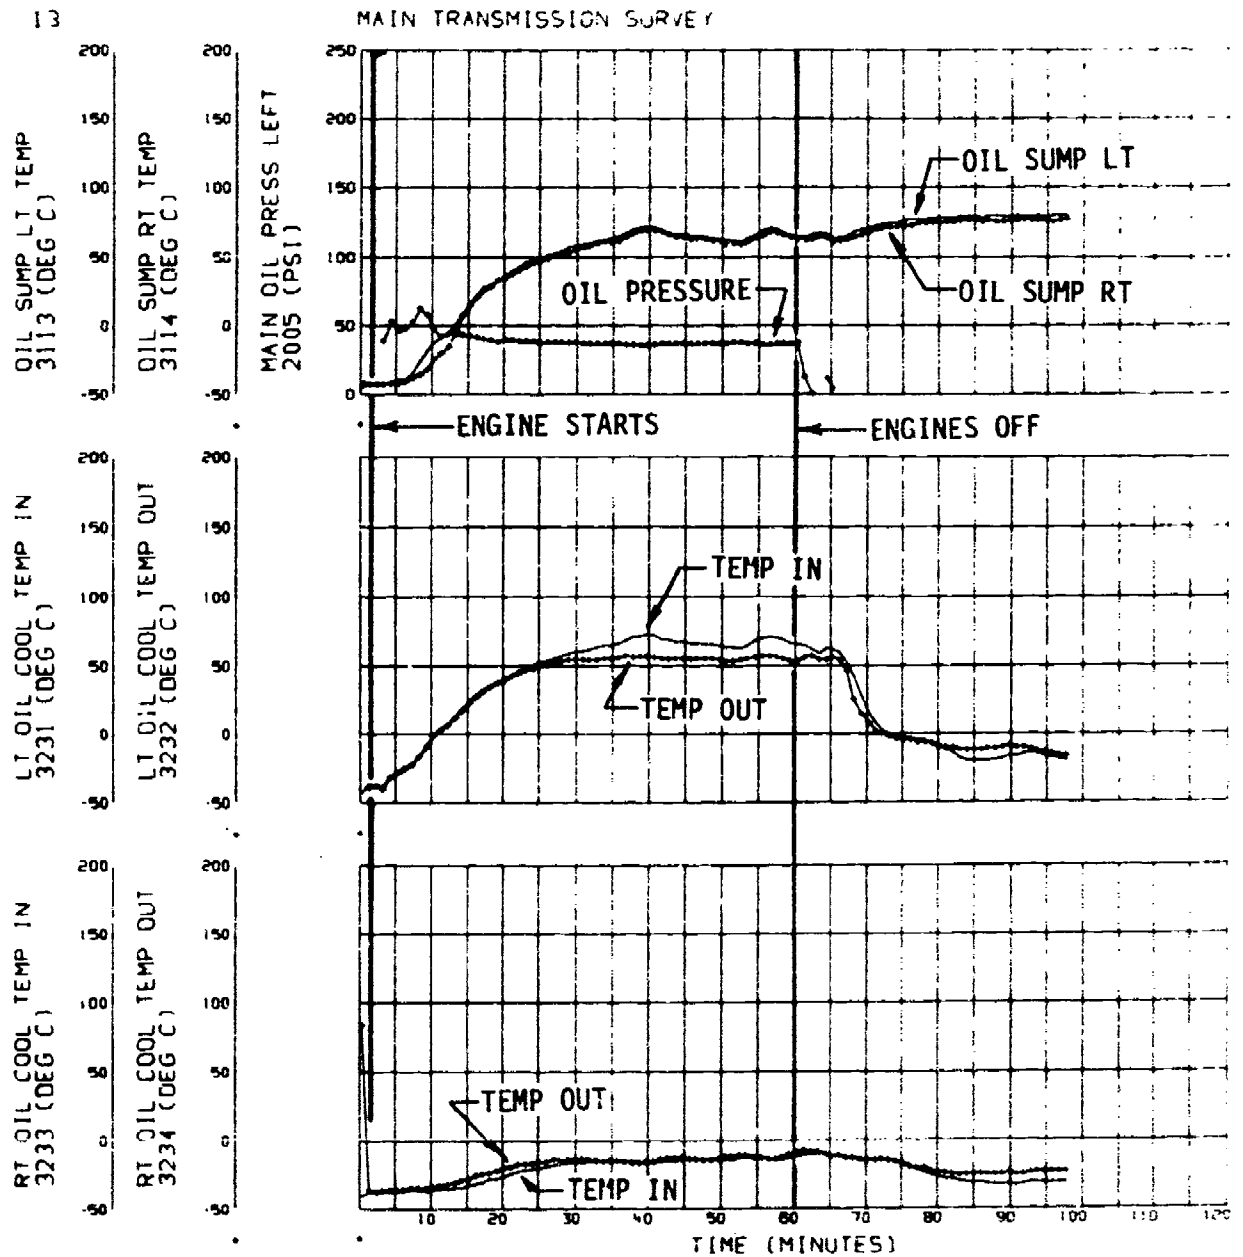
FIGURE 64
MAIN TRANSMISSION SURVEY

- NOTES:**
1. TRANSMISSIONS SERVICED WITH MIL-L-7808H OIL
 2. MAIN TRANSMISSION RIGHT-HAND OIL PUMP BROKEN
 3. MAIN TRANSMISSION LEFT-HAND PUMP OIL PRESSURE INSTRUMENTATION FAILED 60 MINUTES INTO THE RUN.

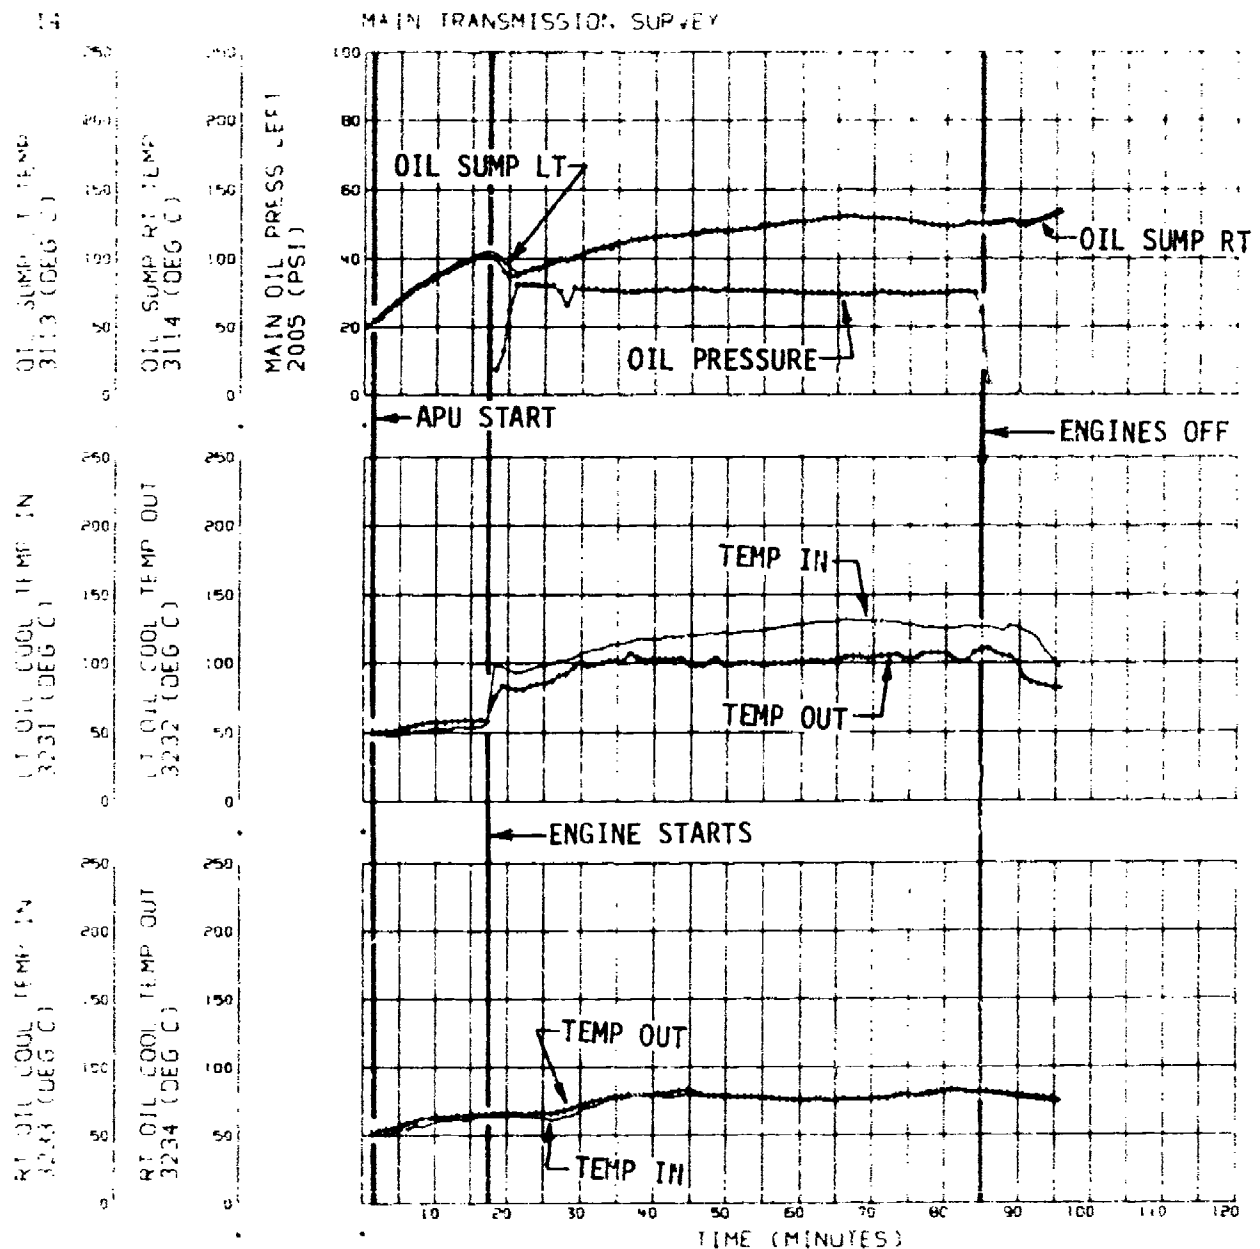
FIGURE 65
MAIN TRANSMISSION SURVEY
YAH-64 USA S/N 74-22249
CLIMATIC LABORATORY TEMPERATURE 125°F

- NOTES:**
1. TRANSMISSIONS SERVICED WITH MIL-L-7808H OIL
 2. RIGHT HAND MAIN TRANSMISSION OIL PUMP FAILED

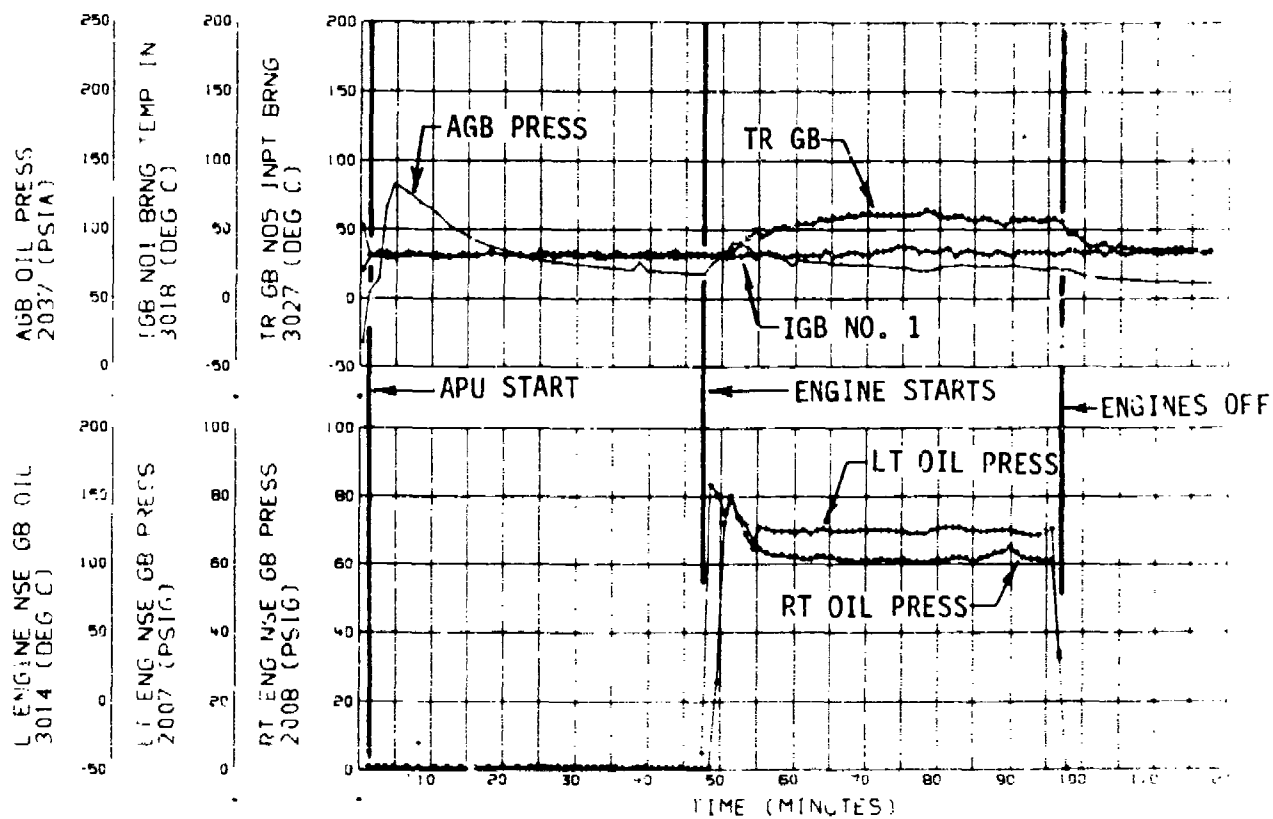
FIGURE 68
TRANSMISSION SURVEY
YAH-64 USA S/N 74-22249
CLIMATIC LABORATORY TEMPERATURE -25°F

- NOTES:
1. TRANSMISSIONS SERVICED WITH MIL-L-23699C OIL
 2. LEFT ENGINE NOSE GEARBOX OIL TEMPERATURE INSTRUMENTATION FAILED

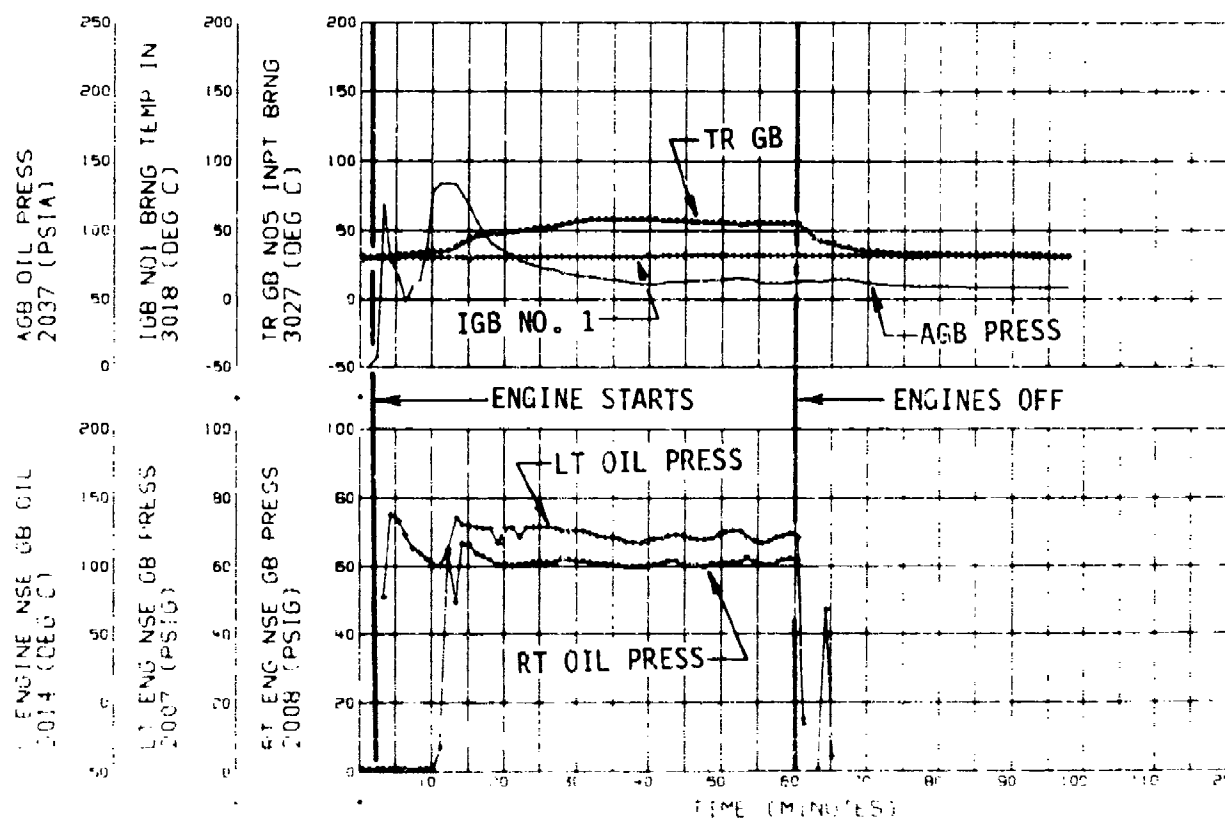
FIGURE 69
TRANSMISSIONS SURVEY
YAH-64 USA S/N 74-22249
CLIMATIC LABORATORY TEMPERATURE -50°F

- NOTES:
1. TRANSMISSIONS SERVICED WITH MIL-L-7808H OIL
 2. LEFT ENGINE NOSE GEARBOX OIL TEMPERATURE INSTRUMENTATION FAILED

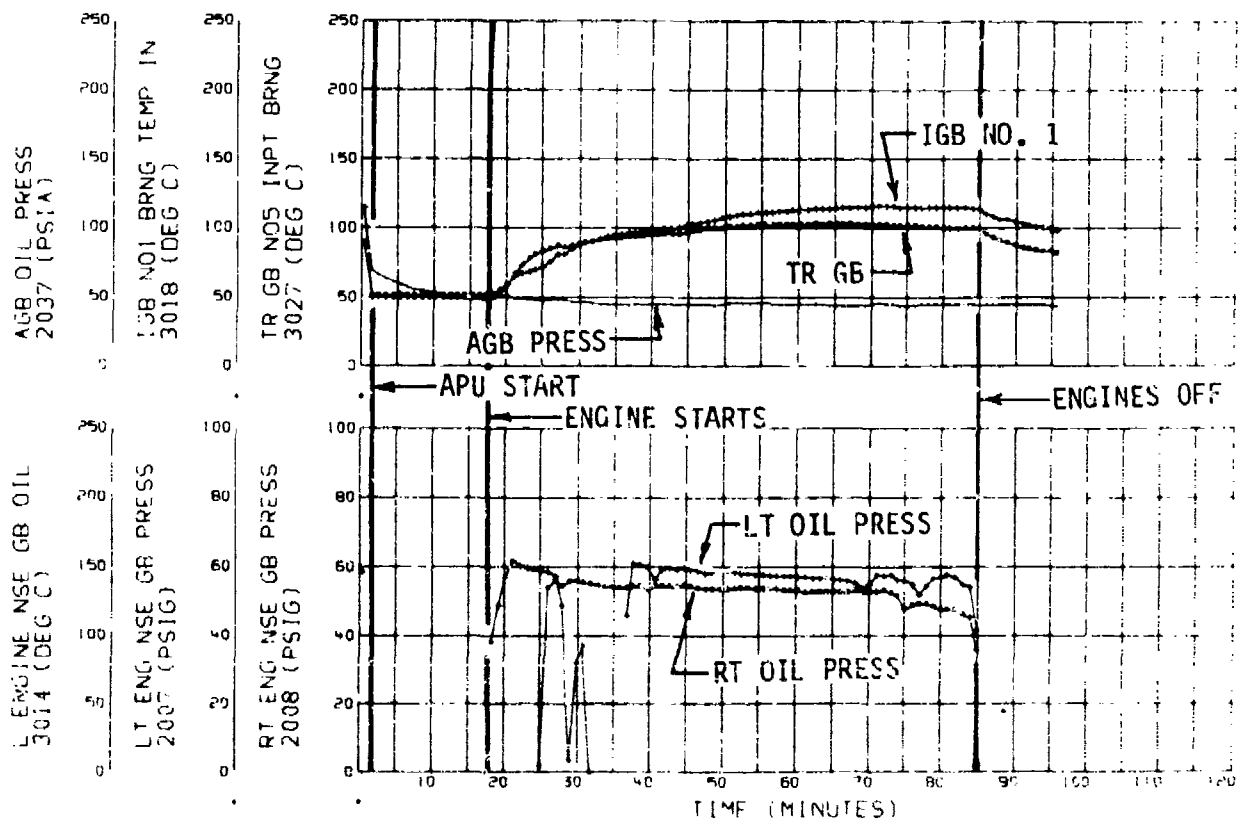
FIGURE 70
TRANSMISSIONS SURVEY
 YAH-64 USA S/N 74-22249
 CLIMATIC LABORATORY TEMPERATURE 125°F

- NOTES: 1. TRANSMISSIONS SERVICED WITH MIL-L-7808H OIL
 2. LEFT ENGINE NOSE GEARBOX OIL TEMPERATURE
 INSTRUMENTATION FAILED

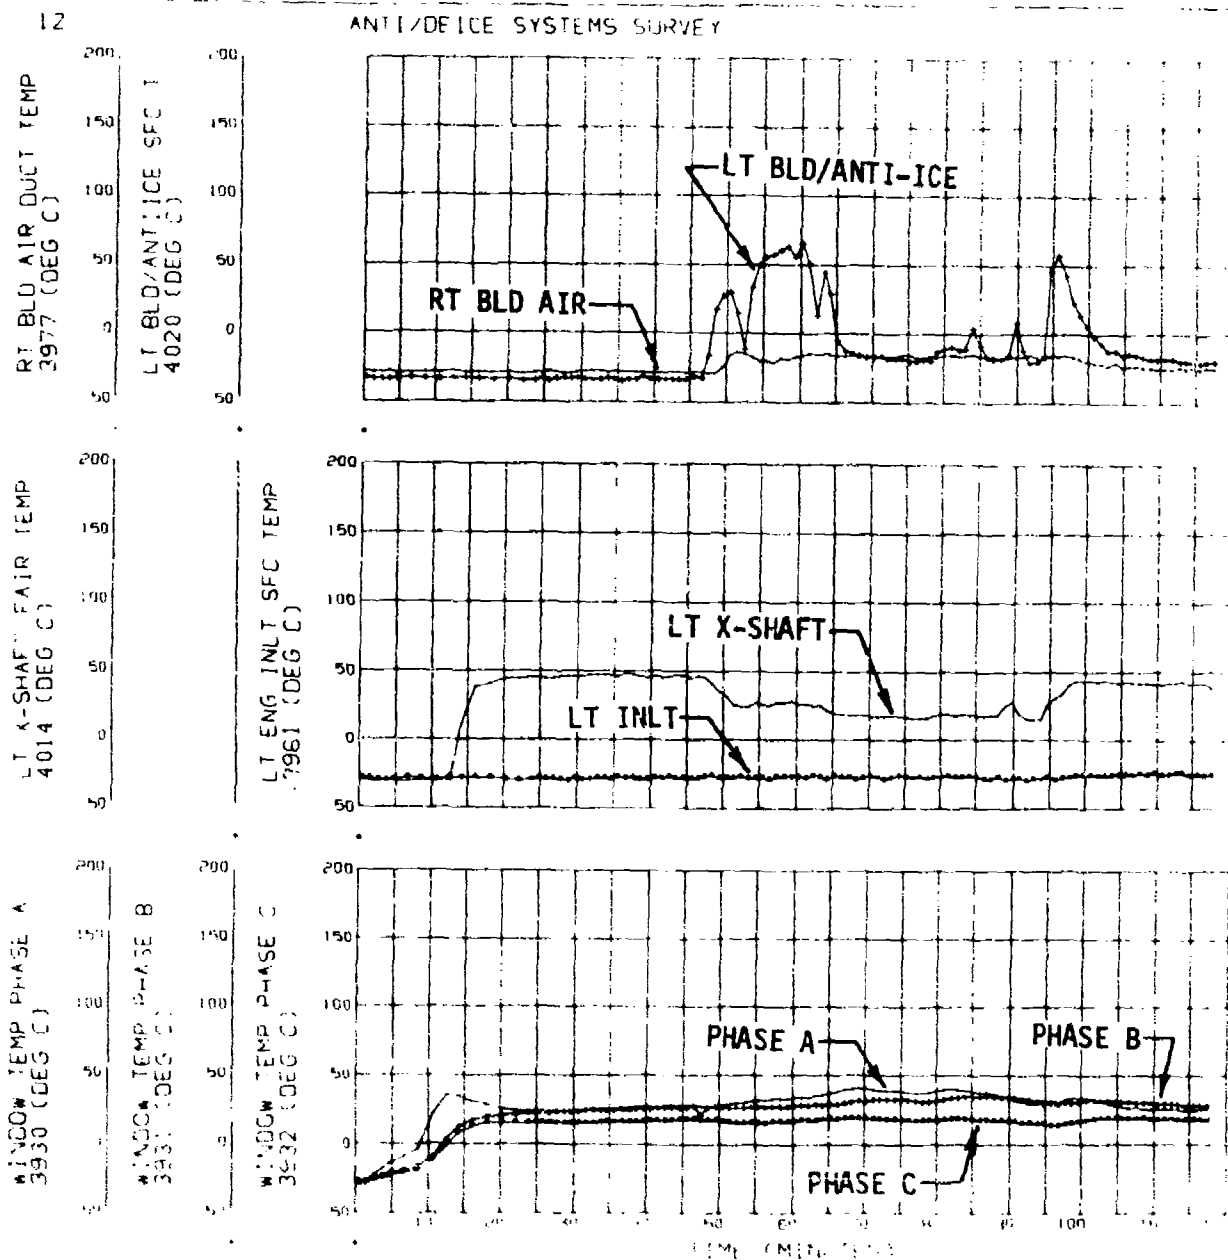
FIGURE 73
ANTI/DE-ICE SYSTEMS SURVEY
YAH-64 USA S/N 74-22249
CLIMATIC LABORATORY TEMPERATURE -50°F

51. Anti-ice systems evaluated during this test were designed to protect the engines, the engine inlet fairings, the engine nose gearbox fairings, the cross shaft fairings, two windshield panels, and the TADS/PNVS components. The TADS/PNVS anti-ice systems evaluations are discussed in appendix H. These tests were not conducted in an icing environment and therefore the anti-ice capability could not be fully evaluated. All systems functioned properly in that they heated components they were designed to heat (fig 71 through 73, app E).

NOTE: LEFT ENGINE CROSS-SHAFT FAIRING INSTRUMENTATION FAILED
